ID: CIP 304

Name: Gallin Court Stream & Culvert Improvements

Study Area: Bull Mountain

Location: Between SW Greenfield Drive and SW Gaarde Street

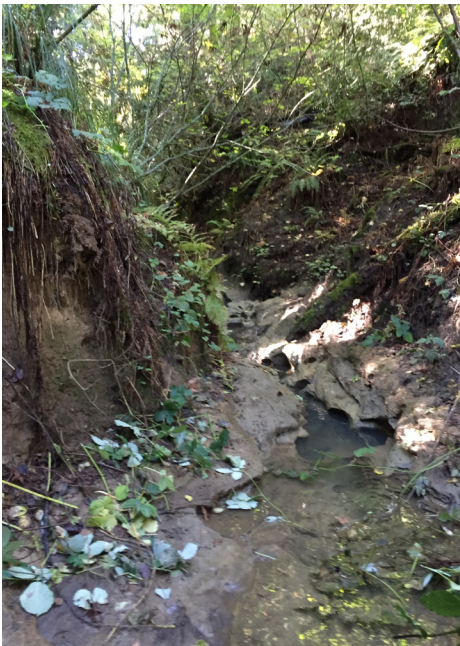
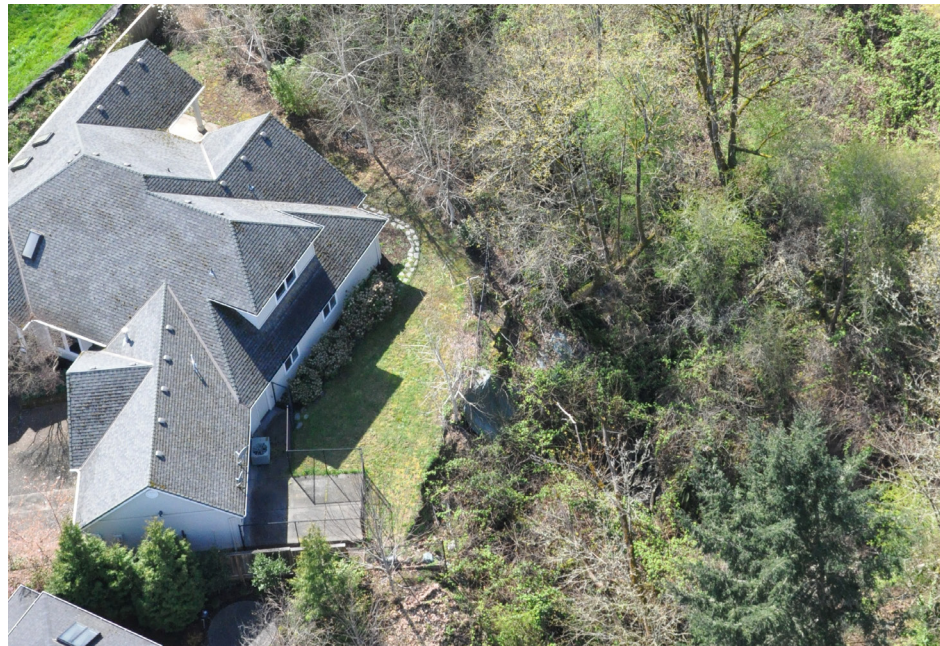
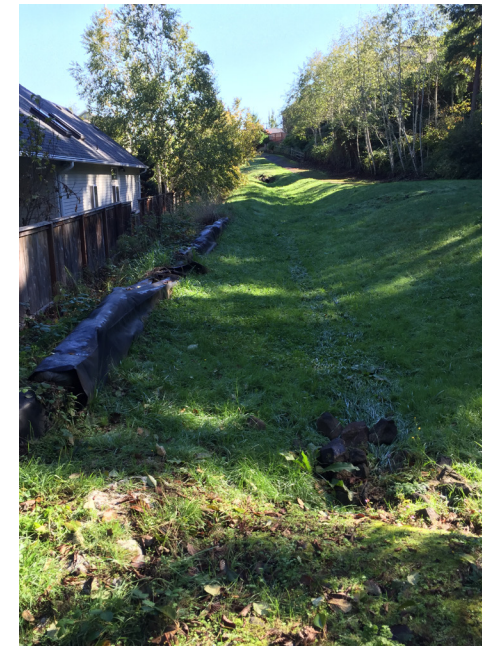
Between SW Greenfield Drive and SW Gaarde Street, severe bank erosion has caused extensive landslides on both banks. Part of a private property on SW Gallin Court has eroded away very close to a house. The City purchased the property to prevent a life safety hazard.

Upstream, an uncovered culvert is separating and needs repair. An outfall is perched seven feet above the channel, and it is damaging the stream banks.

Downstream, public sanitary and storm sewers are located at the top of the bank. A City project armored the bank with rock, but erosion continues and may undermine the pipes.
