ID: CIP 302

Name: Kruger Creek Ann Court Bank Stabilization & Wetland Enhancement

Study Area: Bull Mountain

Location: SW 124th Avenue and SW Ann Court

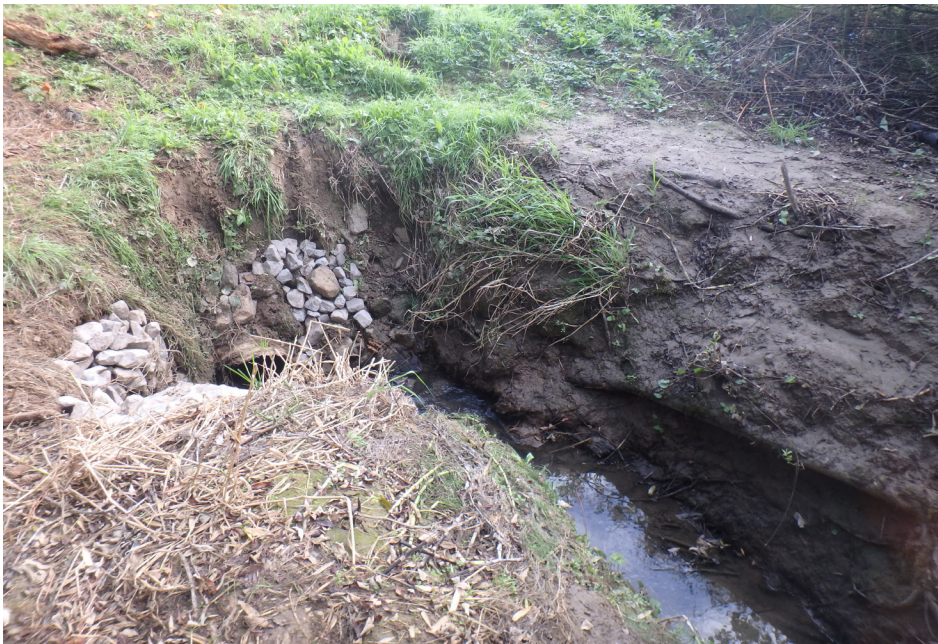
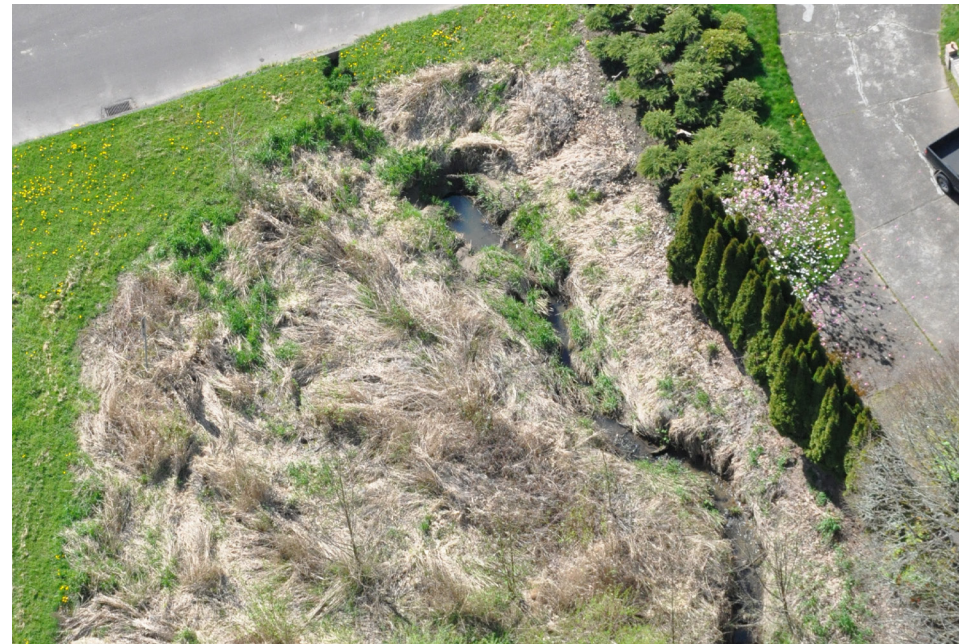
Kruger Creek crosses under SW 124th Avenue in the Jack Park Greenway. The culvert is being damaged by erosion at the upstream end. The City's effort to reduce erosion by adding rock has not stopped the damage.

banks are vertical and high, separating the channel from its floodplain. Erosion is threatening to undermine the driveway of a private home next to the greenway.

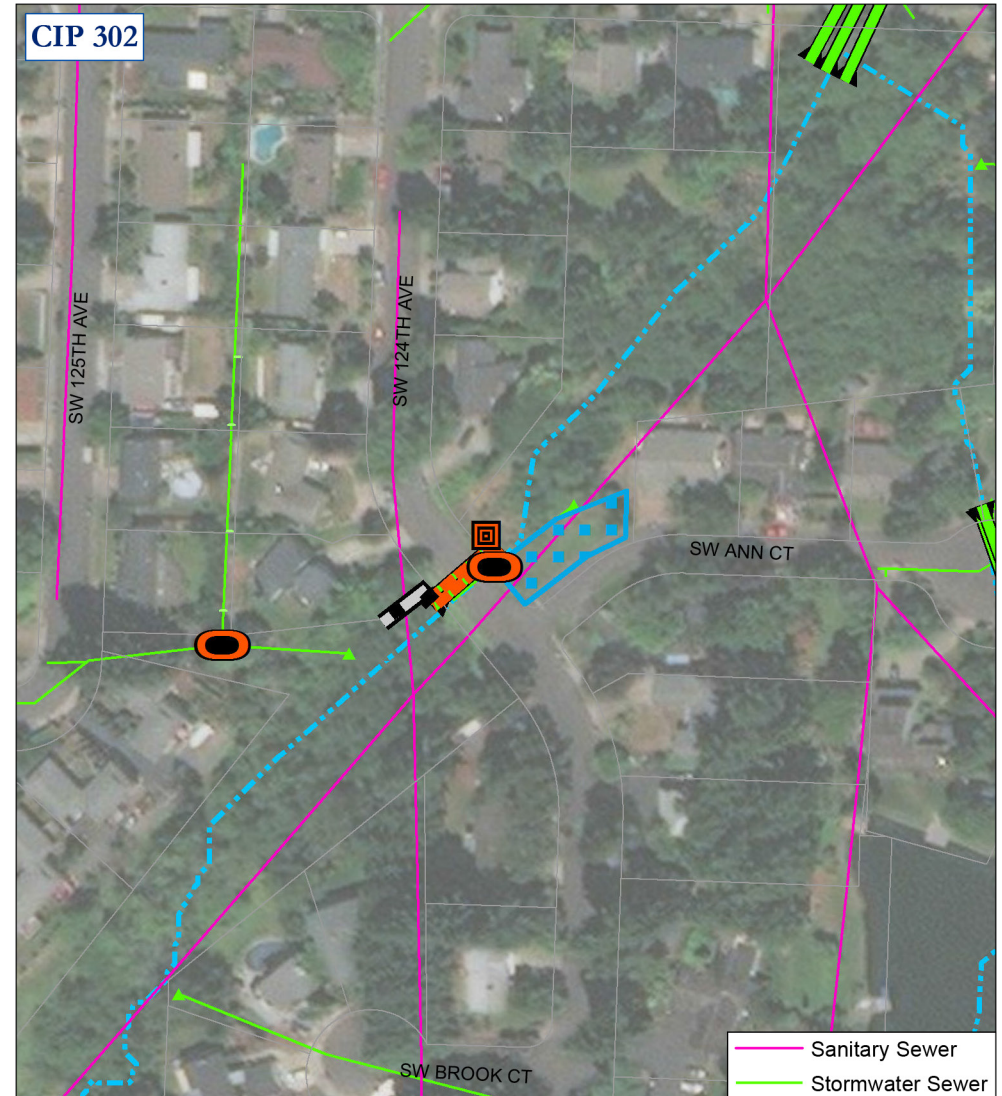
1, Above Ground Storage
-

8, Outfall Scour Protection
-

10, Retaining Wall
-

12, Settling Basin
-

13, Storm Sewer Pipe

The project will replace the damaged culvert with a larger fish-passable culvert under SW 124th Avenue.

Upstream of the crossing, a new pre-settling basin above the storm system outfall will help remove sediment. A new retaining wall will protect the private driveway from being undermined.

A new pre-settling basin and outfall scour protection at the downstream end of the new culvert also will protect the channel and banks from erosion and sedimentation.
