## MEMORANDUM

To: Susan Shanks and Dave Roth  
Organization: City of Tigard  
From: Jess Zdeb, AICP and Gwen Shaw, EIT  
Project: Tigard WSRC Update

### Re: SW Greenburg Road Existing Conditions and Recommendations

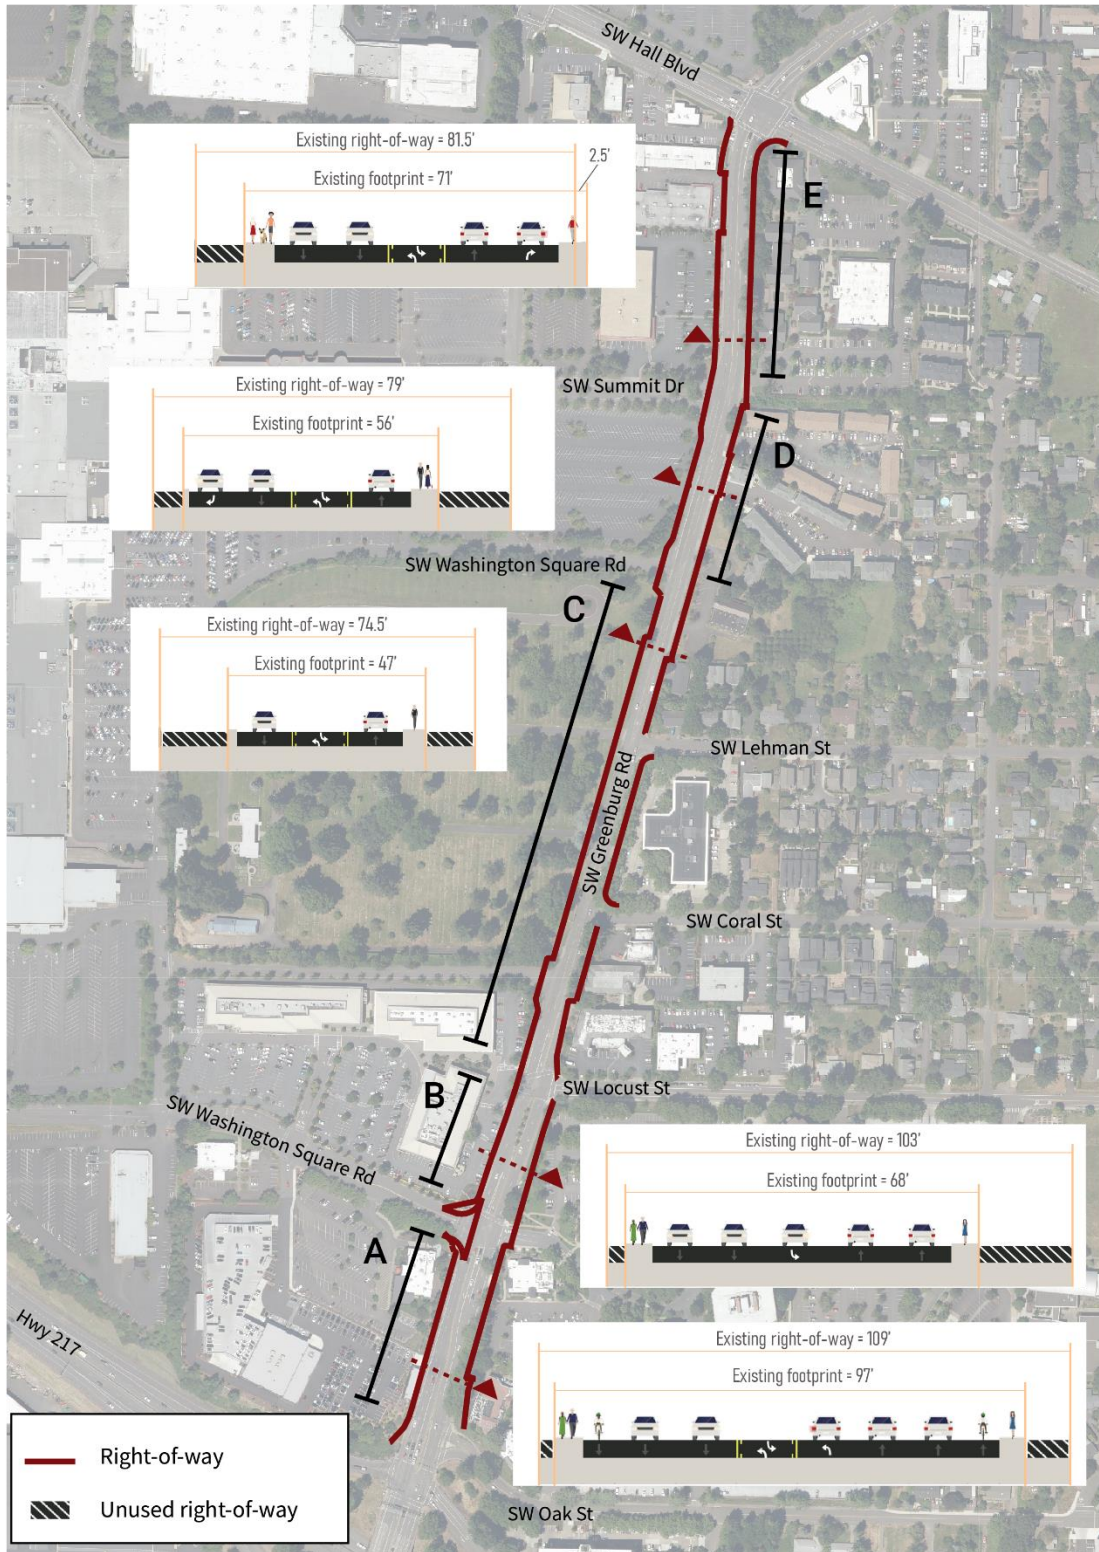
Figure 1. Study Area and Existing Conditions Summary

For the purposes of this study, the corridor has been broken up into five segments, as shown in Figure 1. Figure 2 summarizes additional bicycle and pedestrian facility considerations.

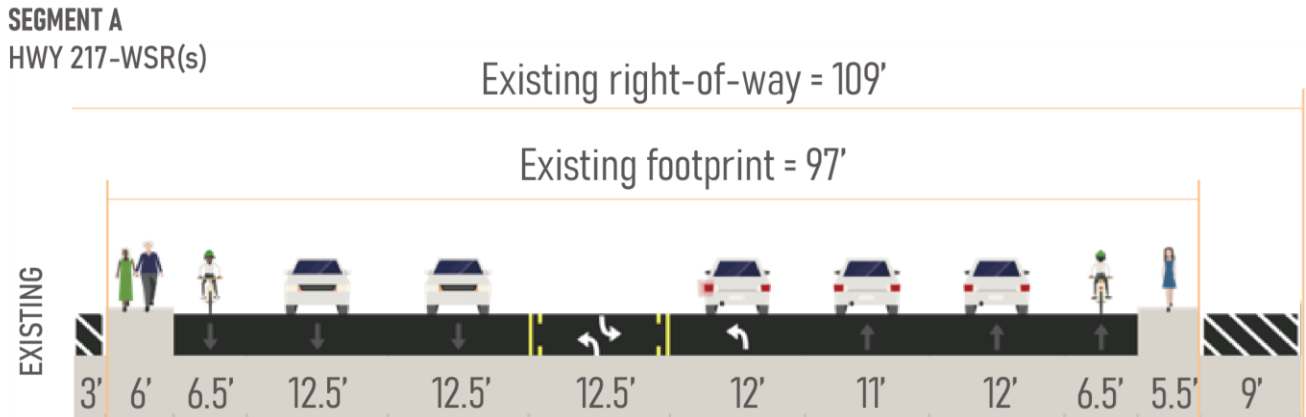
**Figure 3. Existing Conditions for Segment A**

**Segment A:** Between Highway 217 and SW Washington Square Road (south), SW Greenburg Road has two through lanes in each direction and provides dual left turn lanes (380 feet and 180 feet, respectively) turning onto SW Washington Square Road. In the southbound direction, a captive storage lane is provided for the eventual left turn onto Highway 217 south of the study area. Sidewalks are present on both sides of the street. Standard curbside bike lanes are provided in both directions and end at SW Washington Square Road.

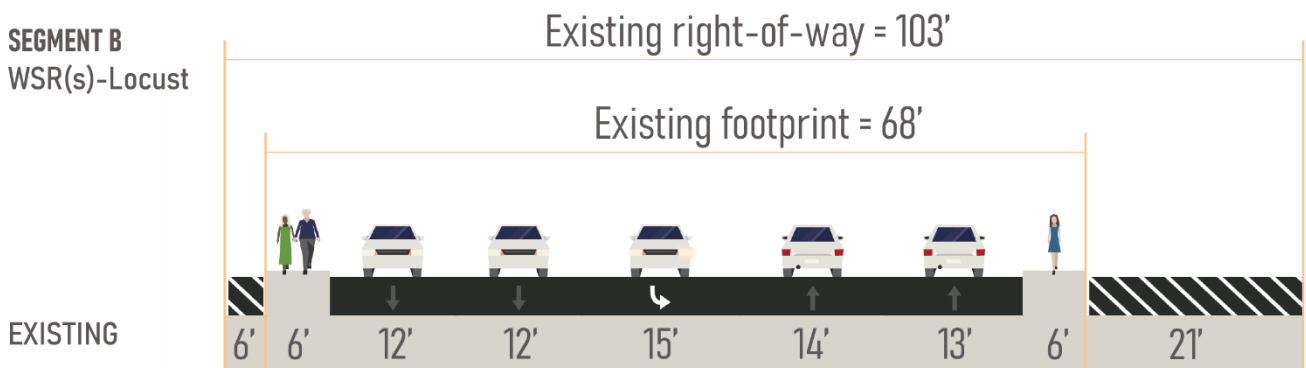
**Figure 4. Existing Conditions for Segment B**

**Segment B:** Between Washington Square Road (south) and SW Locust Street, SW Greenburg Road has two through lanes in each direction and approximately 300 feet north of SW Locust Street, transitions to one through lane in each direction. In the northbound direction, left turns at Locust into the shopping center are prohibited, and right turns are made from the wide outside travel lane. In the southbound direction, left turn lanes are provided onto SW Locust Street and SW Washington Square Road (both 100 feet); and a 60-foot right turn pocket is provided at SW Locust Street to access the shopping center. Sidewalks are present on both sides of the street. There are no bike lanes in this segment.

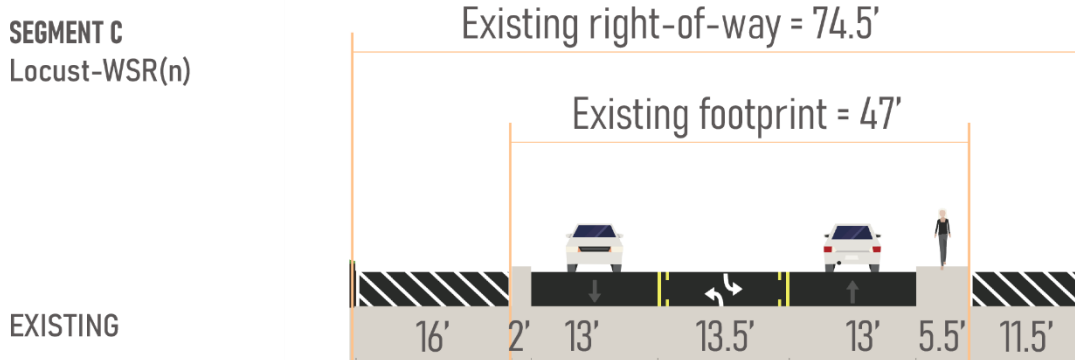
**Figure 5. Existing Conditions for Segment C**

**Segment C:** Between SW Locust Street and SW Washington Square Road (north), there is a single lane in each direction and a two-way center turn lane. There is a sidewalk on the east side of the street. The west side of the street is directly adjacent to the Crescent Grove Cemetery. Along the length of the cemetery, there is no sidewalk and the gap continues into Segment D, creating a total sidewalk gap of 0.25 miles. There are no bike lanes in this segment.

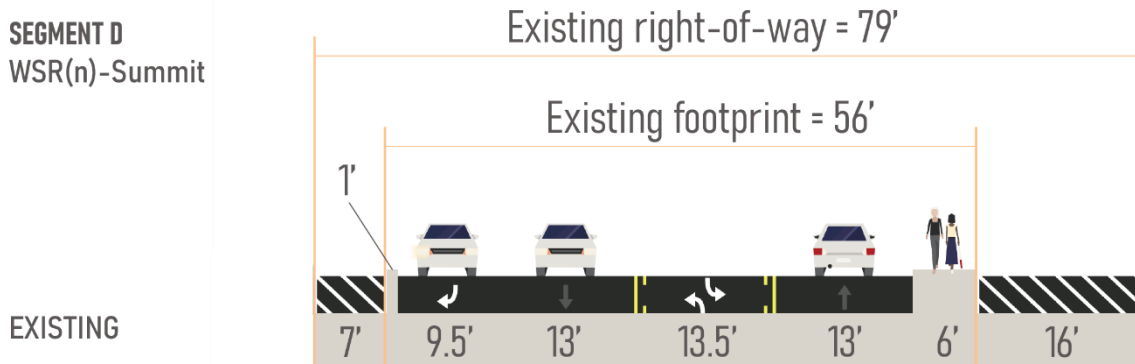
**Figure 6. Existing Conditions for Segment D**

**Segment D:** Between SW Washington Square Road (north) and SW Summit Drive, an additional southbound lane is present which serves as a right turn lane. There is a sidewalk on the east side of the street and no sidewalk on the west side; this is part of the 0.25 mile gap noted in Segment C above. There are no bike lanes in this segment.

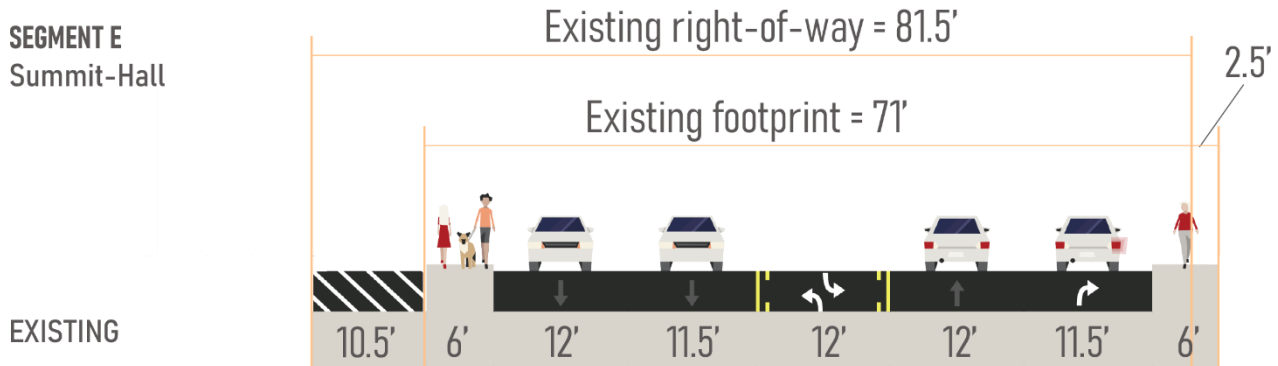
**Figure 7. Existing Conditions for Segment E**

**Segment E:** Between Summit Drive and SW Hall Boulevard an additional northbound lane is present. The two-way center turn lane transitions to a northbound left turn onto SW Hall Boulevard, and the outside lane serves as the right turn lane. One northbound through lane continues north as SW Oleson Road. There is sidewalk on both sides of the street. There are no bike lanes in this segment.

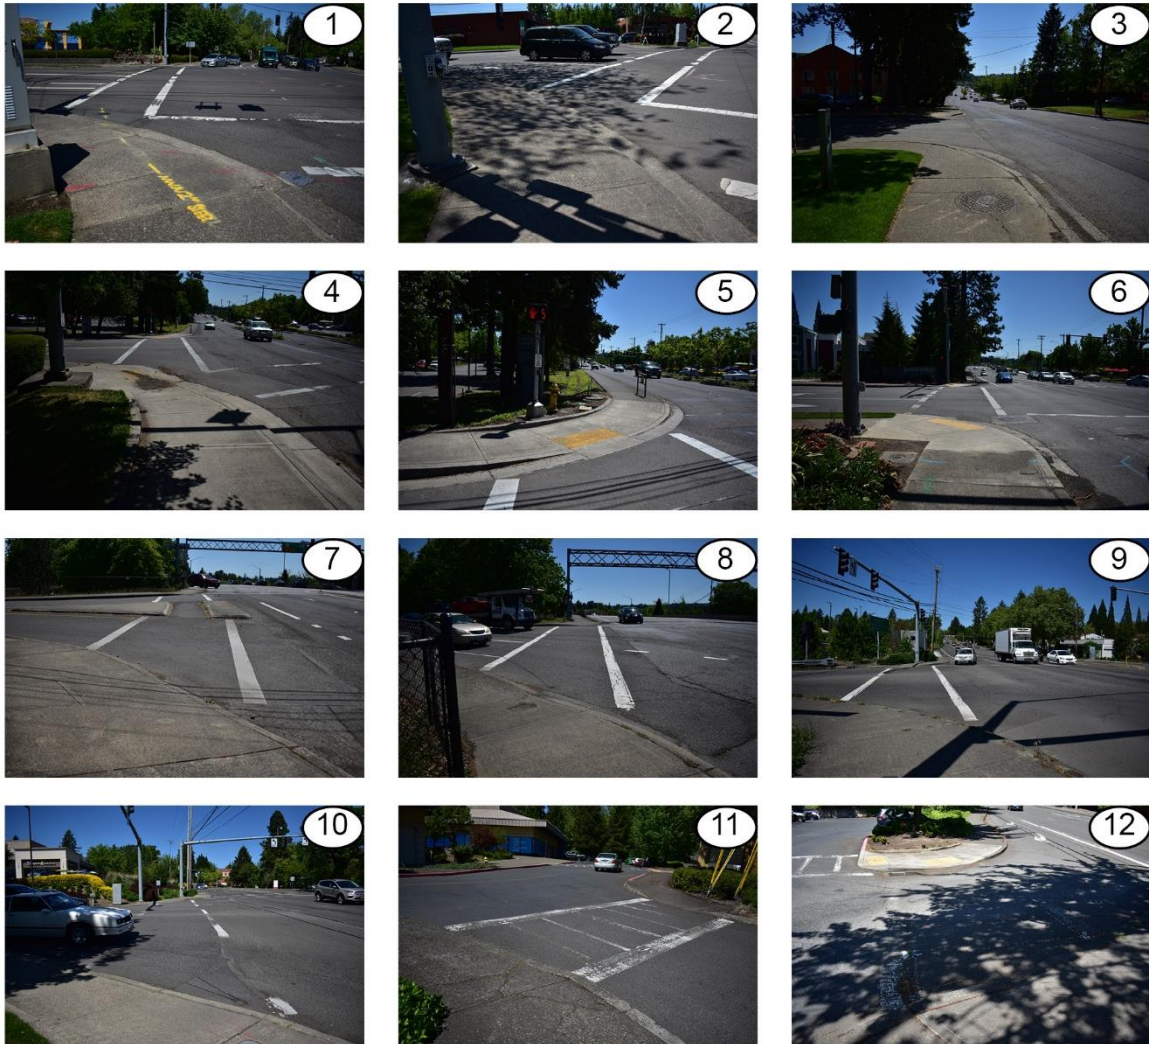
Figure 9. Existing Curb Ramp Conditions for People Walking and Rolling

At intersections, the diagonal curb ramp directs users very close to the adjacent travel lane due to the lack of furnishing zone in the sidewalk and the large corner radii present at the majority of intersections. Additionally, the large corner radii encourage high speeds for motorists turning on and off the roadway.

Photos highlighting the wide range of curb ramp conditions along the SW Greenburg Road corridor.

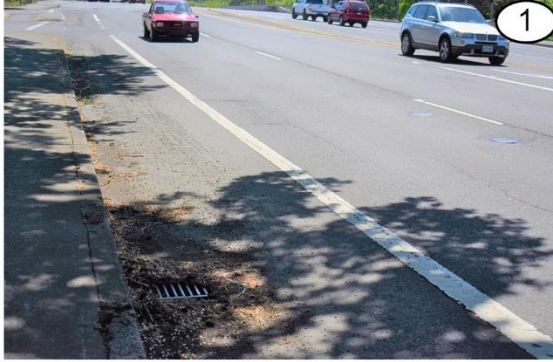
**Figure 10. Conditions for People Bicycling**

If bike lanes were to be installed along additional portions of SW Greenburg Road, designers should consider the presence of a one-foot gutter pan and drainage grates. Seams between gutter pans and asphalt can decrease the functional width of the bike lane, and grates with larger holes parallel to the direction of travel can present a hazard to people biking catching their wheels.

**Drainage grates located in bike lane collecting debris.**  
(photo faces north)

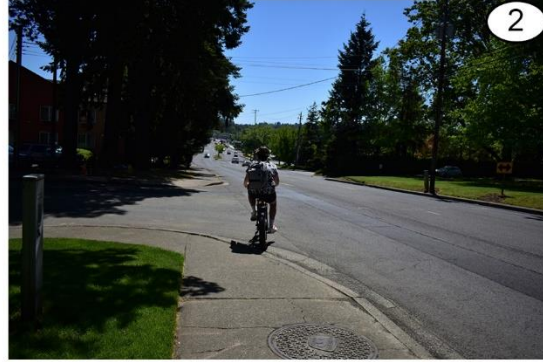
**Person riding bicycle southbound on east side sidewalk.**  
(photo faces south)

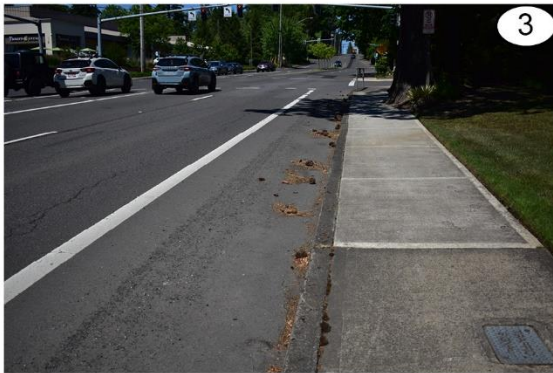
**Debris in bike lane and multiple abandoned driveways (right) in sidewalk, compounding the debris issues.**  
(photos face north)

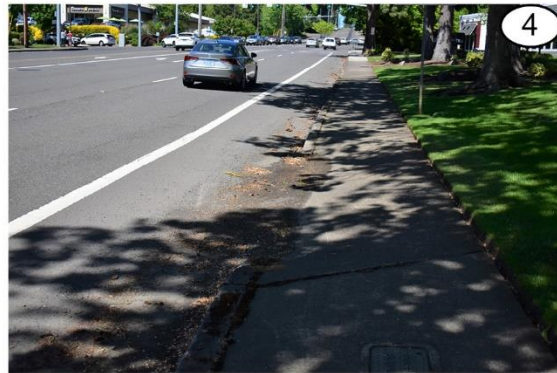
**Debris in bike lane and multiple abandoned driveways (right) in sidewalk, compounding the debris issues.**  
(photos face north)

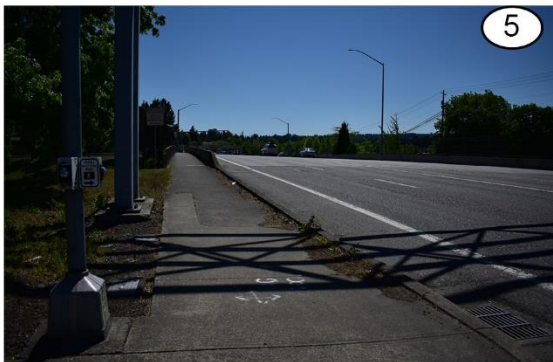
**Sidewalk and northbound bike lane on SW Greenburg Road on the overpass of Highway 217.**  
(photo faces south)

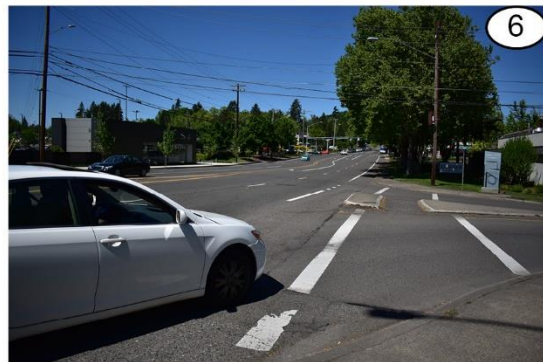
The lack of continuous bike lanes and the few crossing opportunities present the largest barrier to people riding bikes along the SW Greenburg Road corridor. The large corner radii encourage high motorist turning speeds, increasing the severity of a potential conflict. Based on standard best practice for assessing bicycle facilities, the existing bike lanes would be classified as "high-stress" due to their lack of physical separation from 35-mph traffic at volumes exceeding 15,000 vehicles per day. This condition leads to only a small segment of the population truly feeling comfortable enough to bike along SW Greenburg Road. Many people biking may choose to do so on the sidewalk, so conditions described in the previous section also impact them. Given the narrow width of the sidewalk, use by both modes creates potential congestion and conflicts for people walking and rolling.

**Motorist turning onto SW Oak Street from SW Greenburg Road, crossing the bike lane. Large corner radii facilitates high speeds.**  
(photo faces north)

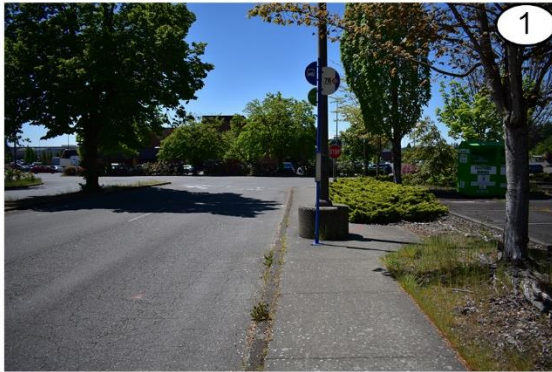
Figure 12. Existing Conditions for People Taking Transit

North/westbound bus stop on Summit Drive. Accessible by sidewalk in both directions.  
(photo faces west)

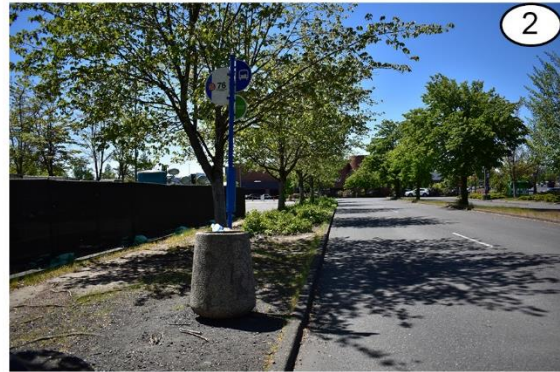
South/eastbound bus stop on Summit Drive. Not accessible by sidewalk in either direction; clear walkway in grass near parking lot (construction fence at edge of parking lot in photo).  
(photo faces west)

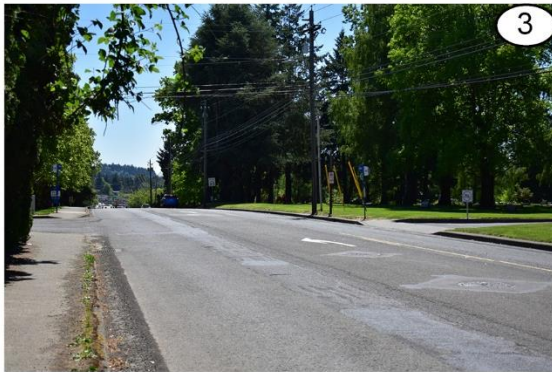
Bus stops on SW Greenburg Road at SW Lehman Street. Northbound (left) stop is accessible by sidewalk in both sides. Southbound (right) stop is not accessible by sidewalk in either direction.  
(photo faces south)

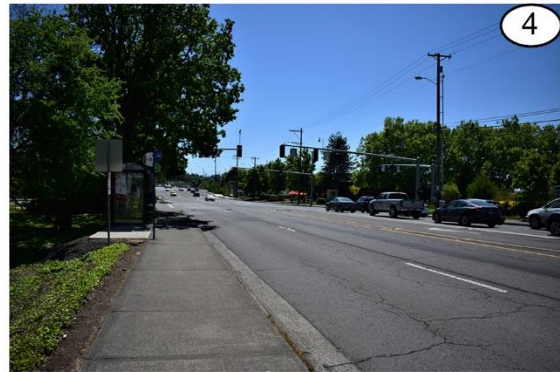
Bus stops on SW Greenburg Road at SW Washington Square Road (south). Northbound (left) stop has an additional paved waiting area behind the sidewalk. Both stops are accessible by sidewalk in both directions.  
(photo faces south)

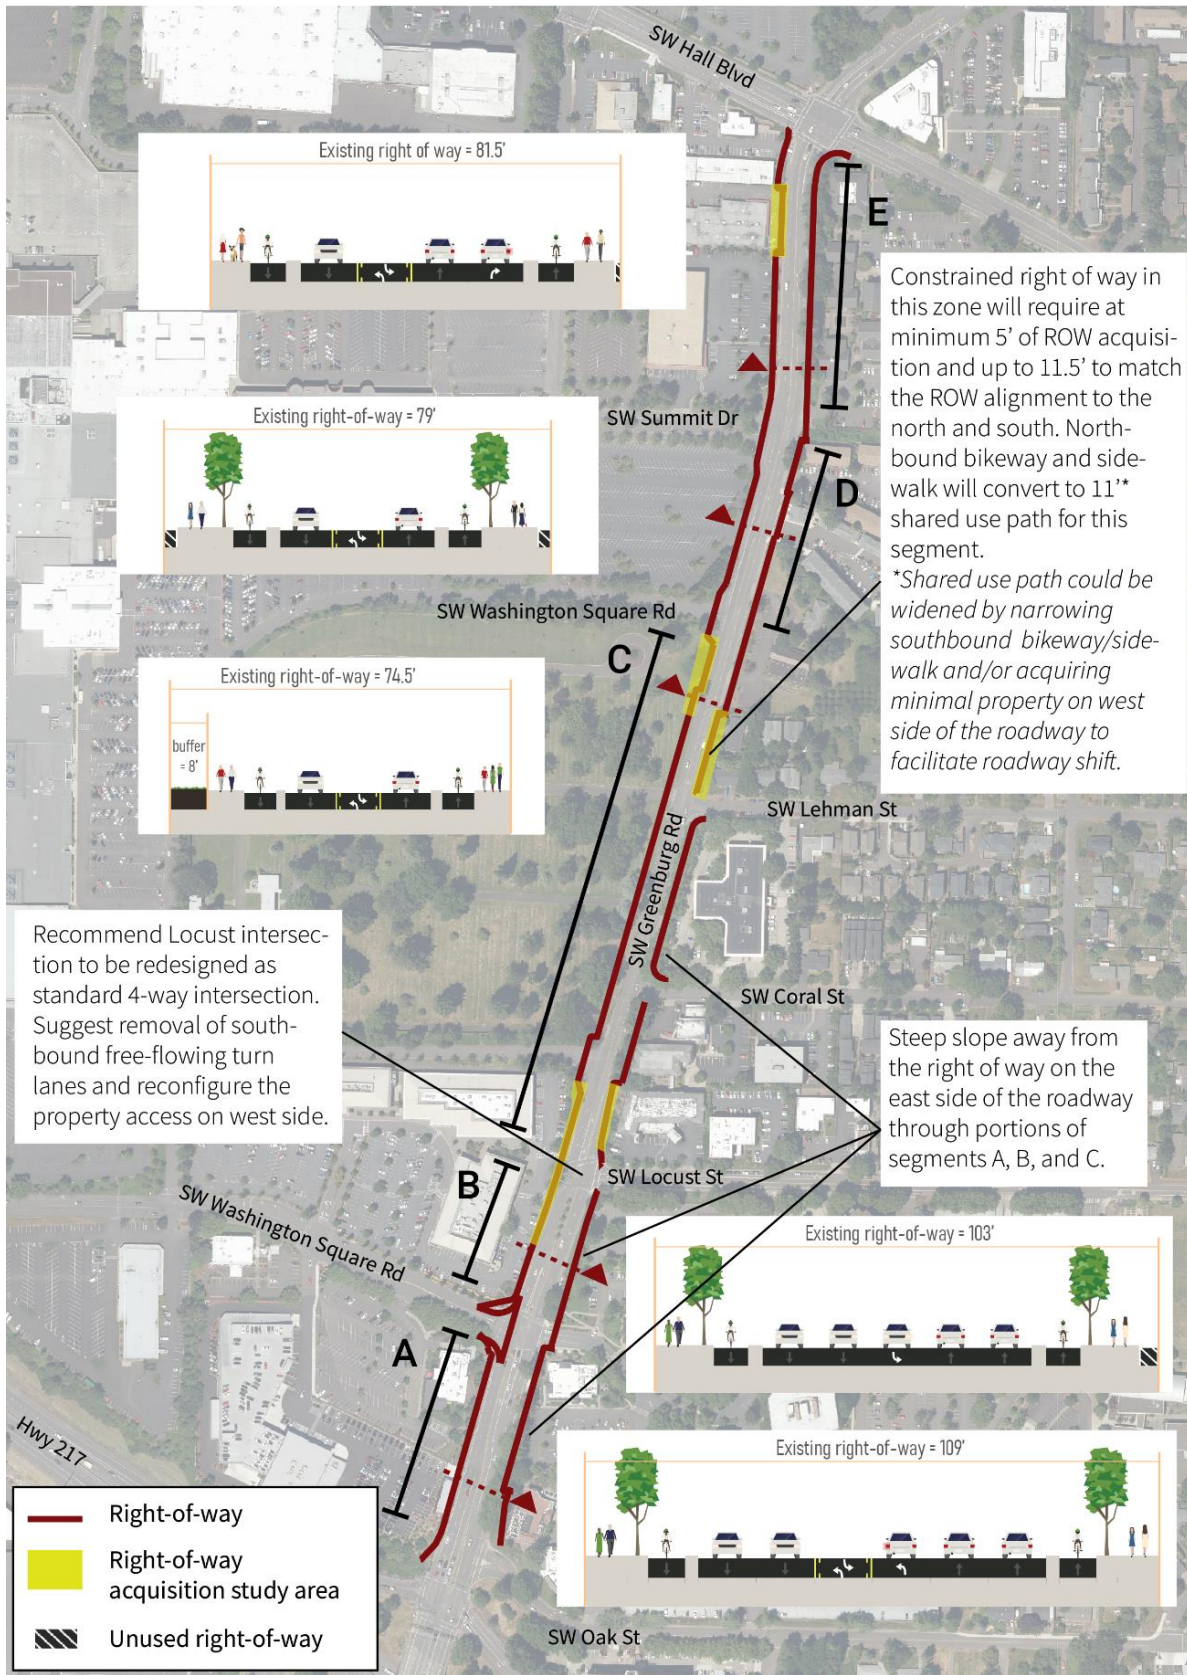
**Figure 15. Cross-Section Recommendations by Segment**

Figure 15 shows the proposed cross section for each of the five segments. Locations where right-of-way acquisition should be studied are shown. These locations are primarily where the current right-of-way pinches or is at an angle different from that of the roadway creating pockets that need more analysis. These recommendations were determined via measurements from Google Earth and GIS shapefiles and are not based on a topological survey. Further study is necessary to confirm feasibility and actual measurements.

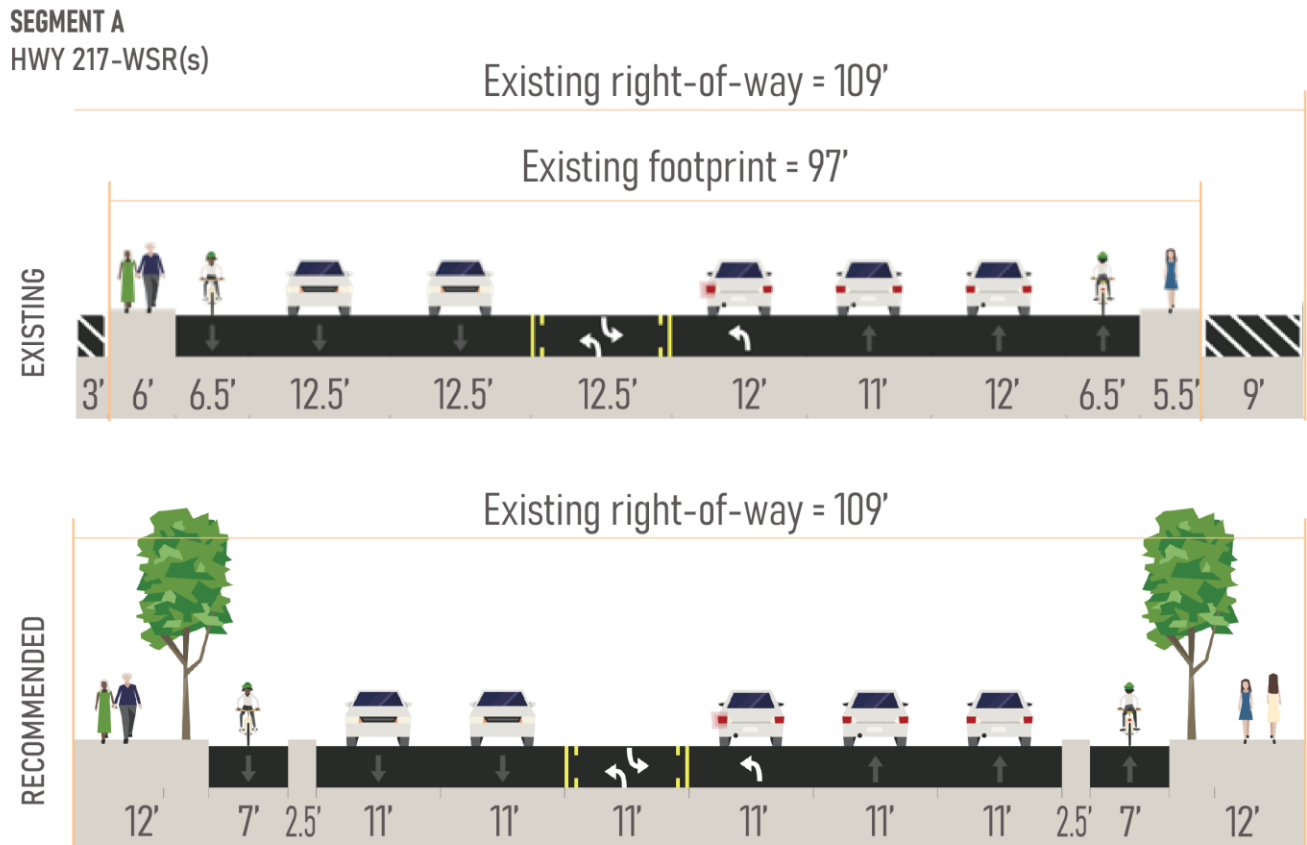
Figure 16. Existing and Recommended Cross Sections for Segment A

Segment A is the portion of the corridor closest to Highway 217 and therefore has limited flexibility in the number of lanes provided and requires slightly more capacity than the rest of the corridor in order to avoid impact to Highway 217 operations. In this segment, it is recommended that all travel lanes, including turn lanes, be narrowed to a consistent 11 feet. In combination with using the unused right-of-way, this provides enough space for a separated bike lane and sidewalk with furnishing zone. In this segment, the bikeway buffer is 2.5', slightly below the preferred 3' buffer, but still wide enough to fit most vertical element options.

In this segment, the landscaped area behind the sidewalk on the east side of the road is currently lined with large trees. Further analysis will be needed to understand how close to the right-of-way they are and if it is feasible to maintain them and shift elements of the bike and pedestrian facilities to work around them. If not, it should be noted that while new trees would be planted in the new cross section location, they will not have the same mature canopy as the existing trees.

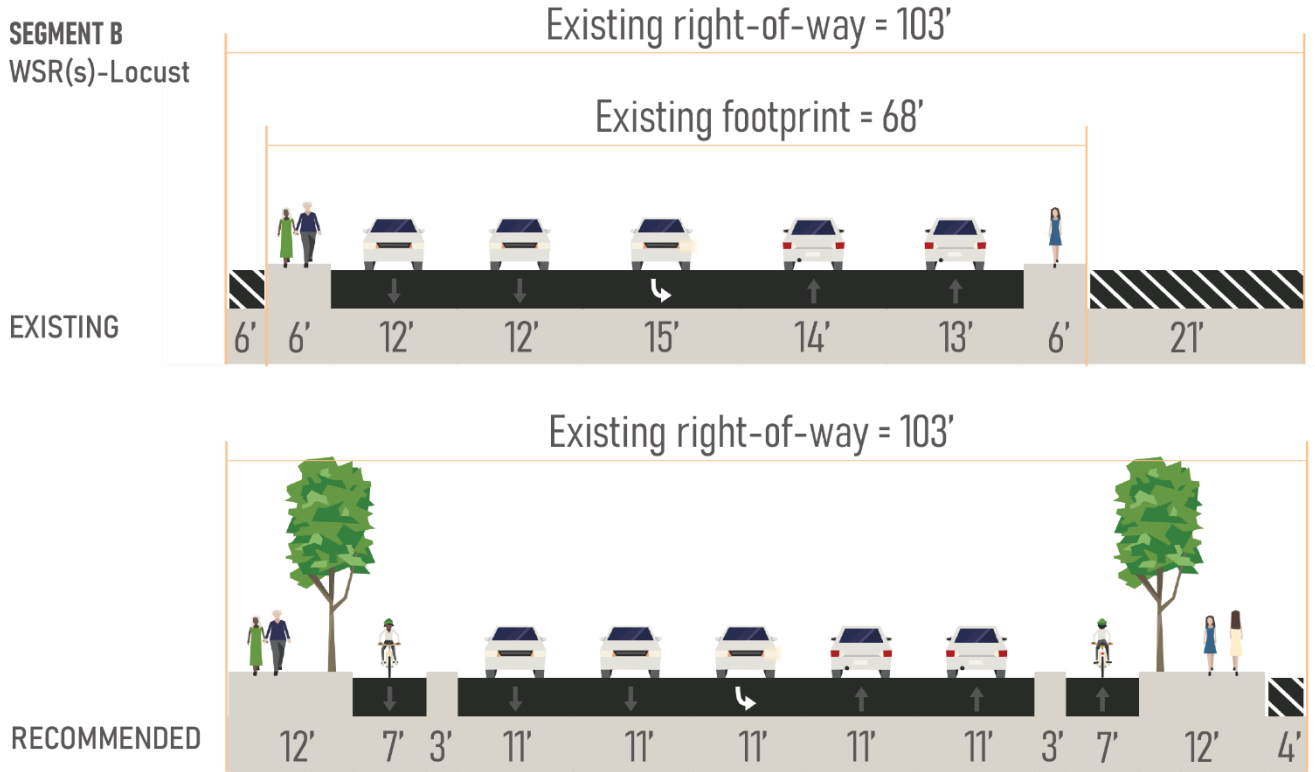
**Figure 17. Existing and Recommended Cross Sections for Segment B**

Similar to segment A, this segment has a need for increased automobile capacity due to the proximity to Highway 217 and being the primary access to the Washington Square Mall. Currently, there is a large amount of unused right-of-way, primarily on the east side of the road, and a lesser amount on the west side. The majority of unused right-of-way is utilized in the recommended cross section and several spot locations may require right-of-way acquisition in order to maintain a consistent cross section (i.e. the sidewalk and the right-of-way line on the east side of the street are not parallel). In this segment, it is recommended that all travel lanes, including turn lanes, be narrowed to a consistent 11 feet. In combination with using the unused right-of-way, this provides enough space for a separated bike lane and a sidewalk with furnishing zone. The preferred 3' bikeway buffer is feasible in this section.

The east side of Segment B contains a landscaped area that begins to slope away from the roadway at or beyond the edge of the right-of-way. At the northern end of the segment, there is a several-foot elevation difference between the roadway and the adjacent parking lot. The elevational difference continues to increase as Segment B becomes Segment C and will be a key consideration in the proposed improvements at the SW Locust Street intersection. The Locust Street intersection is discussed in the Crossing Analysis section.

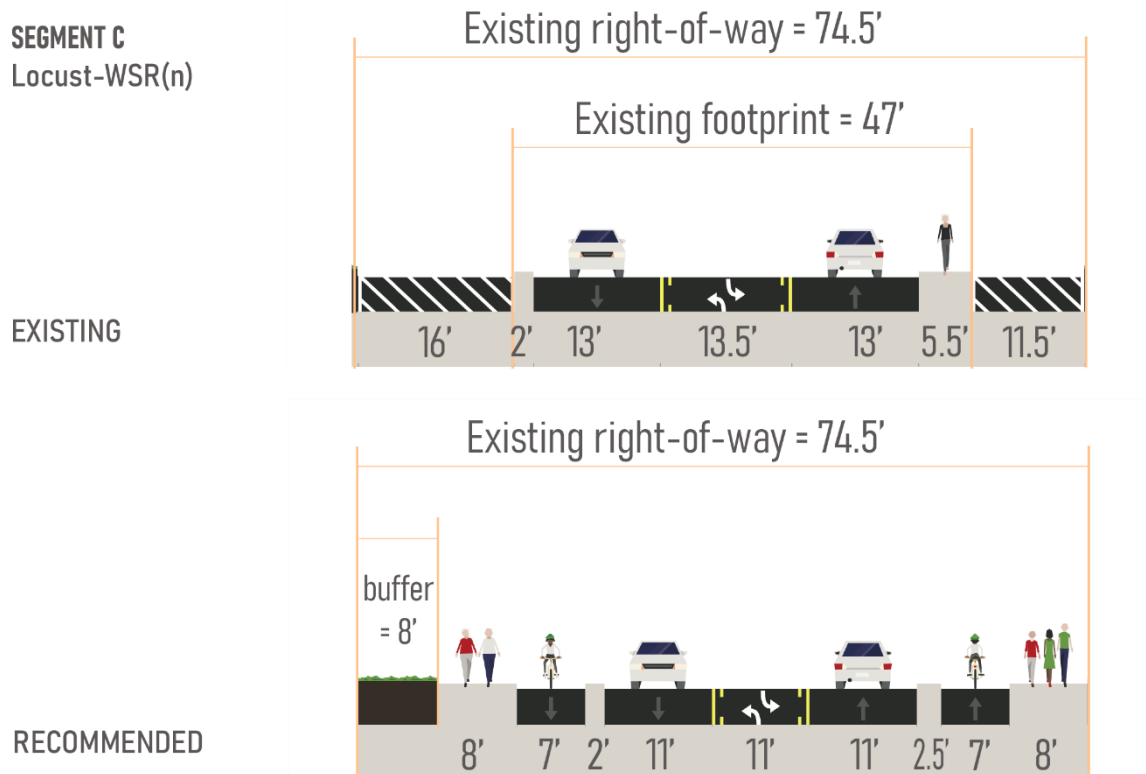
Figure 18. Existing and Recommended Cross Sections for Segment C

Segment C is the most constrained portion of the corridor, bounded to the west by the Crescent Grove Cemetery for the majority of the segment. It is recommended all existing travel lanes be reduced to 11' and to utilize all available right-of-way to achieve minimal widths for the bikeway buffer, bike lane, and the sidewalk.

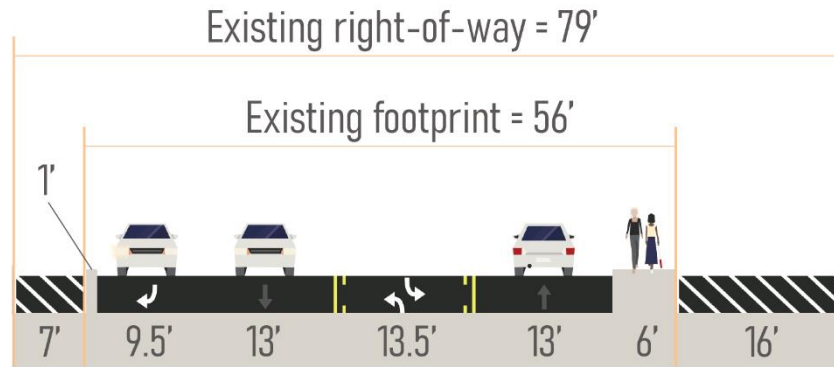
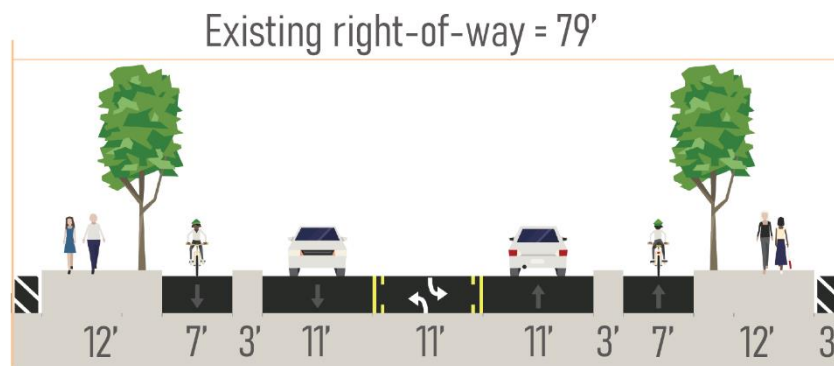
Figure 19. Existing and Recommended Cross Sections for Segment D

Segment D contains the portion of the corridor that has most opportunity for future redevelopment. On the east side, redevelopment is planned for the church as discussed in the Segment C section and a relatively new multifamily complex has been built adjacent to existing multifamily complexes. On the west side, there are long-term plans to redevelop the mall parking lots and create a double-loaded pedestrian-oriented street at or near where Summit Drive currently exists.

For this segment, it is recommended all existing vehicle travel lanes be reduced to 11' and the southbound turn lane that ends at SW Washington Square Road (north) be removed. With these changes and coupled with unused right-of-way, the preferred widths for each cross-section element are achievable and there is an additional 3' of right-of-way on each side to aid in transitions or provide extra width to elements at key points (e.g., widened sidewalk near a transit stop, widened tree well without narrowing the sidewalk, etc.).

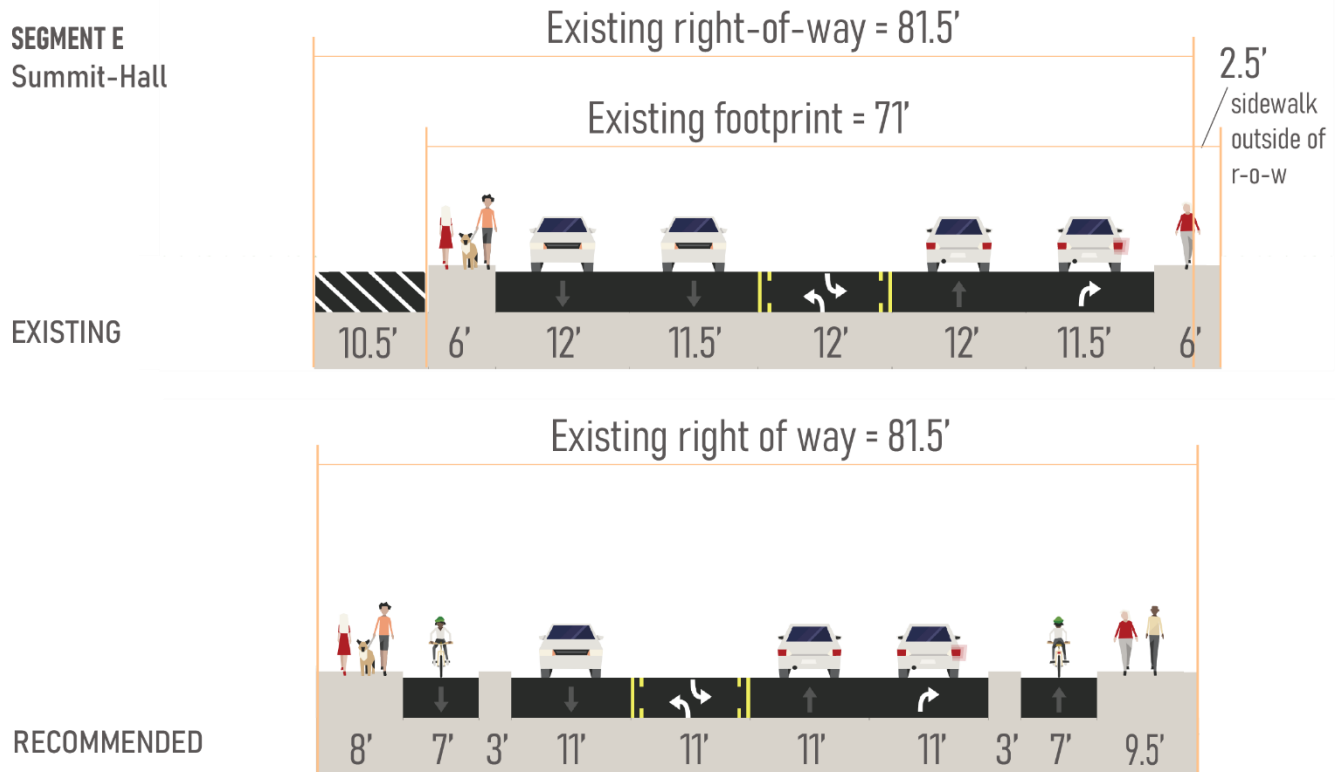
**Figure 20. Existing and Recommended Cross Sections for Segment E**

Segment E will require more vehicular capacity as it approaches SW Hall Boulevard. It is recommended all existing vehicle travel lanes be reduced to 11 feet and one of the two existing southbound lanes be removed. North of SW Hall Boulevard, there is only one southbound lane coming from SW Oleson Road, and the existing second lane on SW Greenburg primarily serves as an auxiliary lane for business access and vehicles turning south from SW Hall Boulevard. As noted in Segment D, this lane becomes a turn-only lane and ends at the SW Washington Square Road (north) intersection.

Figure 20, the existing sidewalk extends 2.5 feet outside of the eastern right-of-way and the recommended cross section footprint shows a 9.5 foot sidewalk that utilizes all of the existing right-of-way width. This extra width could be allotted anywhere in the cross section to provide flexibility in the transition from Segments C and D into Segment E where the roadway curves and right-of-way constraints may force additional shifts in alignment. In the

The right-turn lane onto SW Hall Boulevard would remain and the two-way center turn lane would convert to a left-turn lane as it does under existing conditions. Business access on the west side of SW Greenburg Road just south of SW Hall Boulevard should be a key consideration for final design (see the Existing Conditions section for more information on the current sidewalk gap and driveway configuration).

areas where the existing sidewalk extends beyond the right-of-way, it is recommended the existing sidewalk remain in place to limit the impact to adjacent trees that have matured with the sidewalk in place.

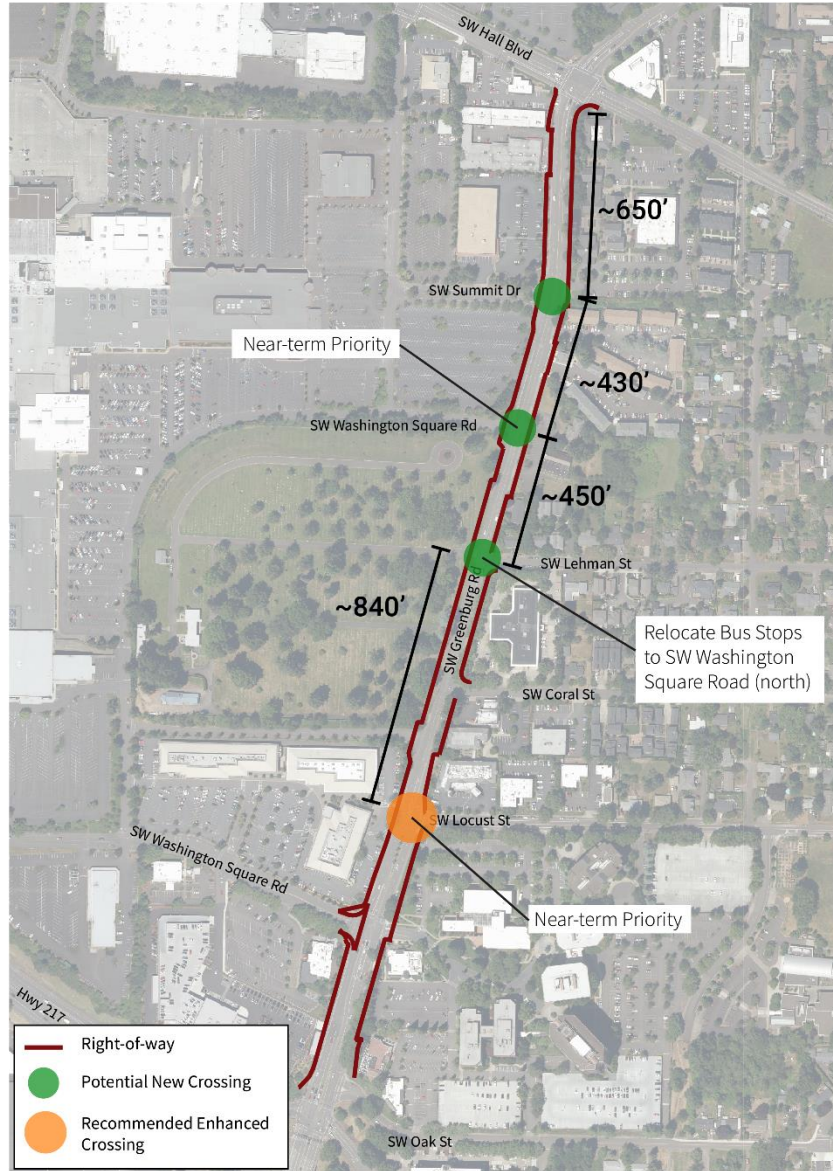
**Figure 21. Crossing Recommendations**

New crossing location recommendations are also included and shown in Figure 21. These crossing projects may be completed in advance of the corridor-length project or as part of the corridor-length project. Recommended crossing treatments are based on existing speeds, volumes, and lane configurations to address sidewalk gaps and long distances between crossing opportunities.

It is recommended that the intersection of SW Greenburg Road at SW Locust Street be reconfigured to create a more standard four-leg intersection. This may involve acquiring right-of-way along the western side pending intersection operations and turn lane requirements. The existing landscaped median would be removed and reutilized in the intersection configuration. Removal of the splitter island that allows for free-flowing movements in and out of the west side driveway is recommended to provide for the west leg of the intersection. Marked crosswalks are recommended on all four legs.

Each of the three above potential crossing locations were considered, but it was immediately identified that they were too closely spaced to recommend all three at this time. Given that SW Summit Drive is relatively close to SW Hall Boulevard and that SW Lehman Street does not presently have sidewalk access or adequate amenities for the bus stop, the SW Washington Square Road (north) location is the recommended priority crossing location. The crossing improvement conditioned on the adjacent redevelopment is also a factor in this recommendation. The City of Tigard and TriMet are discussing the potential relocation of the bus stop at SW Lehman Street to the new crossing location to provide the crossing and an accessible transit stop at the same location. Moving the transit stop increases the distance (~1,300') between the SW Locust Drive signal and SW Washington Square Road (north); however, this is a non-issue because there are no major pedestrian destinations on the west side of the street in that gap.
